## Coal Mine Fatal Accident 2005-17

| Operator: | Drummond Company, Inc. |
| Mine: | Shoal Creek Mine |
| Accident Date: | August 10, 2005 |

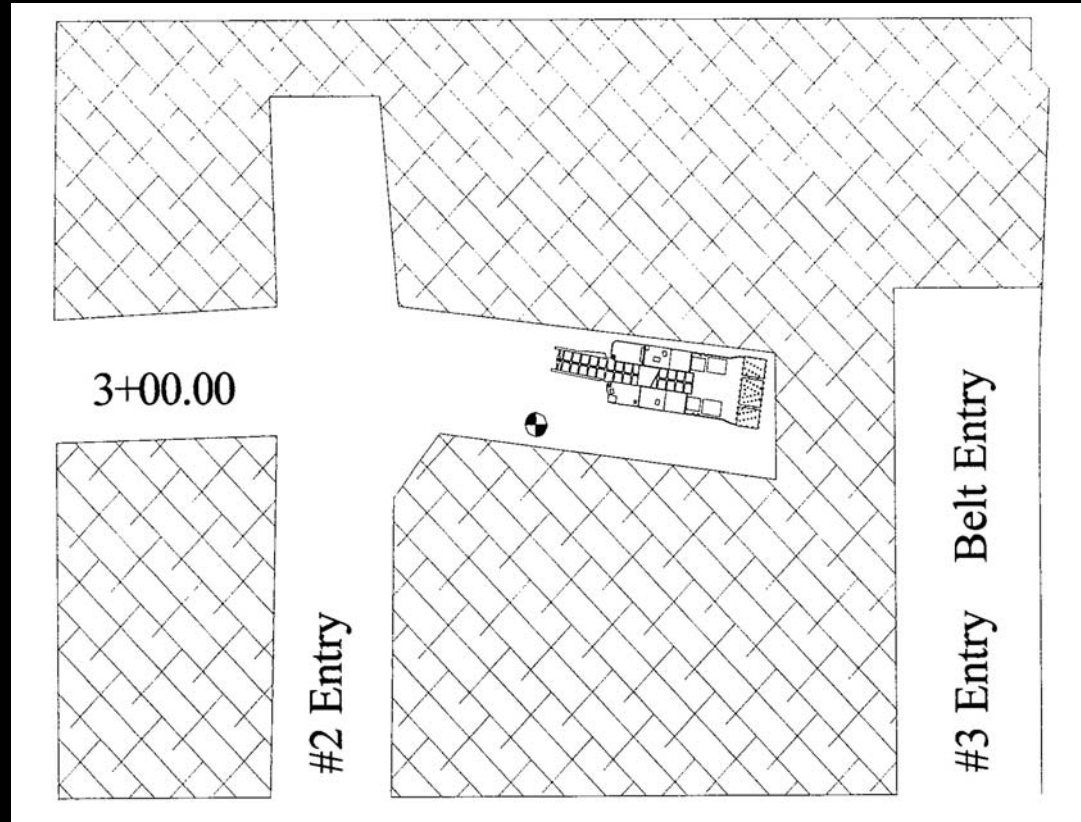
At ~ 8:00 p.m. on Thursday, August 10, a 54-year old continuous miner operator was fatally injured in a roof fall. The victim was struck by a 30" x 30" x 6" piece of roof rock that fell from between the rib and roof bolts. He was operating the continuous mining machine via radio remote control, while standing along the right rib, when the accident occurred. The victim died of his injuries on November 15, 2005. He had 1 year, 13 weeks experience in this occupation.

Causal Factor: A localized geologic discontinuity, exposed during mining, was not recognized and adequate precautions to eliminate the hazard were not taken.

The accident occurred because a localized geologic discontinuity, exposed during mining, was not recognized and adequate precautions to eliminate the hazard were not taken. The victim was struck by a 30-inch x 30-inch x 6-inch piece of roof rock that fell from between the rib and roof bolts.

The operator failed to adequately support or otherwise control the roof (N-0 section, 2-right crosscut) to protect persons from hazards related to falls.

On August 10, 2005, while operating a continuous mining machine, a miner received fatal injuries when a piece of roof rock, 30-inches x 30 inches x 6 inches, fell from between the rib and roof bolt, striking the victim on the head and back. The rock was a localized geologic discontinuity, characterized by smooth contact planes that afforded little adhesion to the immediate roof. This formed an area of natural weakness, constituting a fall of roof hazard. Additional measures, such as additional support and/or scaling, were needed to protect persons working or traveling in the area from this hazard.

Corrective Action: The mine operator installed additional support in the area of the fall. Safety awareness discussions have been conducted on the importance of workplace examinations, emphasizing roof, rib, and floor conditions.
